SEALING THE CRACKS IN MATURE FIELDS

By taking a chance on new technology and a startup company, Maersk Oil has achieved a groundbreaking repair method that could mean hundreds of thousands more barrels of oil recovered from mature fields per year.

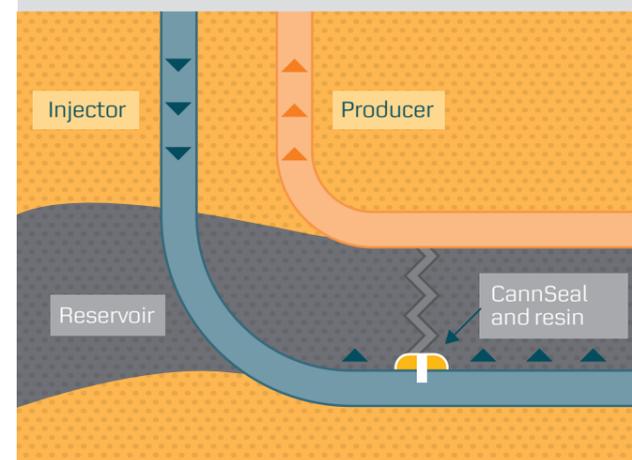
Differentiating technical capabilities leveraged to increase production in mature field

Challenge

- Water injection applied in mature Dan and Halfdan fields
- Reservoir fracture connection makes water injection less effective

Approach

- Fracture identified using 4D (time lapse) seismic
- CannSeal deployed to re-establish conformance control

The CannSeal tool brings epoxy down the well in sealed canisters, perforates the well liner, orientates injection pads around the perforations, and then squeezes epoxy behind the liner. The epoxy forms a plug (or donut) in the annulus behind the liner, thereby providing annular isolation.
